## CASE REPORT

# Esthetic Rehabilitation of Fractured Maxillary Anterior Permanent Tooth Using Glass Fiber Post and Full Coverage Restoration: Case Report

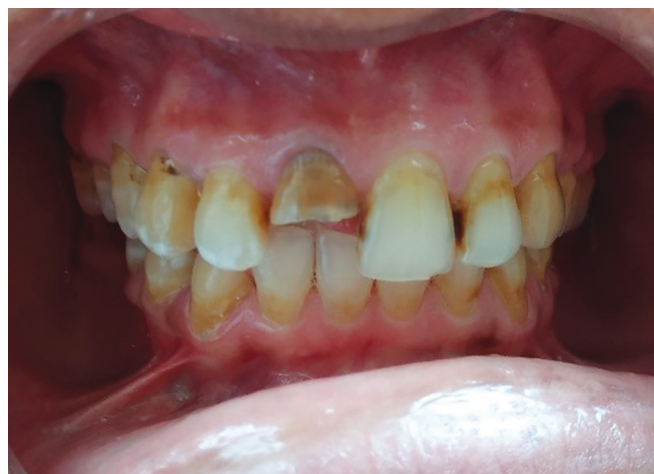
A 48-year-old female patient reported to the Department of Conservative Dentistry and Endodontics with a chief complaint of a discolored upper anterior tooth. On examination maxillary right central incisor was found to be fractured. The patient gave a history of falls 1 year back. The vitality test is done with an electric pulp tester and the cold test did not show any response. On thorough clinical and radiographic examination, the diagnosis was made as Ellis class IV fracture in relation to 11 (Figs 1 and 2). Root canal treatment followed by fiber post and core and full coverage restoration was planned.

**Fig. 1:** Preoperative intraoral photograph

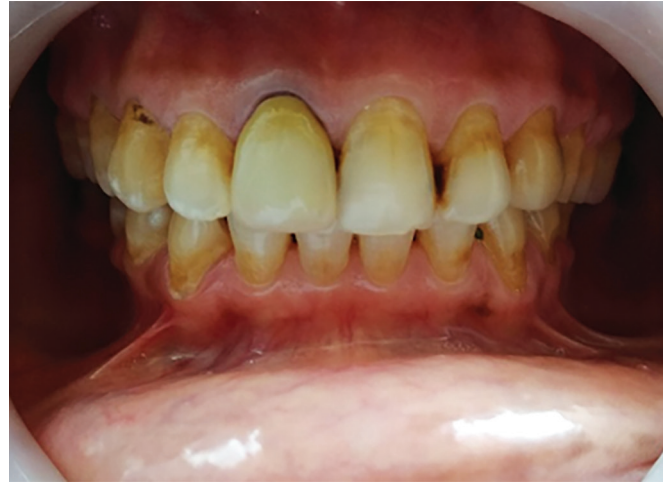
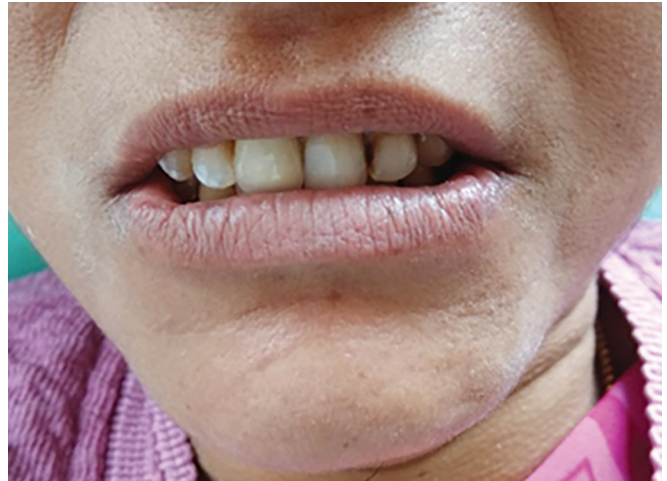
Fig. 9: PFM crown cementation done

Fig. 10: Intraoral photograph

Dual cure resin cement Rely X U200 (3M ESPE, Minnesota, USA) was hand-mixed for 10 seconds. Post was placed into the post space and excess resin cement was removed and light-cured for 40 seconds (Figs 6 and 7). Core built-up was done with light cure composite (Filtek Z350, 3M ESPE, Minnesota, USA). Following this tooth preparation was done to receive a full coverage restoration (Fig. 8). PFM crown was cemented in relation to tooth number 11 (Figs 9 and 10).

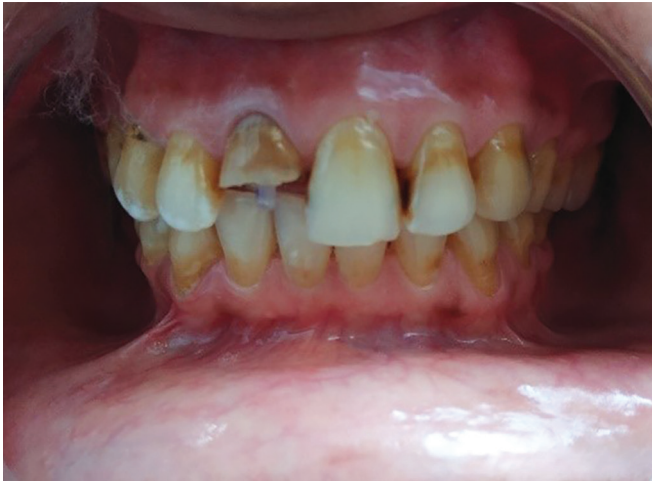
Fig. 6: Fiber post cementation done

Fig. 7: Fiber post cementation intraoral photograph

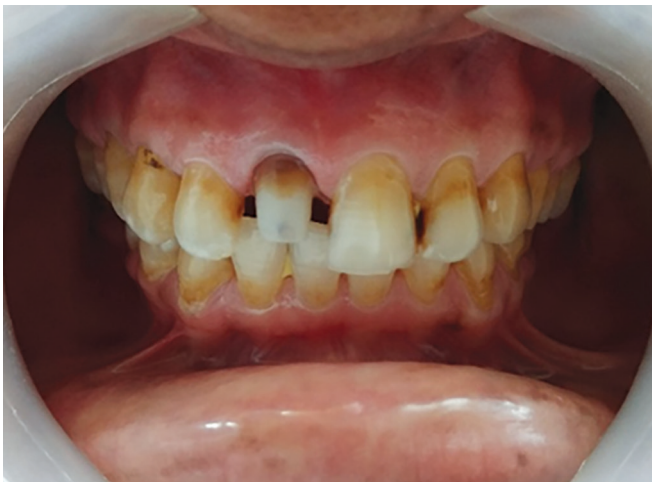
Fig. 8: Crown preparation done
